WT-775

Probability that mass-fires, fire storms, and conflagrations will occur following atomic attack on urban areas depends on extent and distribution of ignitions as well as fuel, topographic, and weather conditions. Prediction of fire probability is important in military target analysis from both offensive and defensive standpoints. Furthermore, factors which affect this probability are also important to civilian defense planning.

Project 8.11b, Operation UPSHOT-KNOTHOLE, is part of a research program sponsored by the Armed Forces Special Weapons Project which seeks to predict the extent and distribution of primary ignitions that may result from atomic explosions over wildland and urban target areas. Mass-fires, fire storms, and conflagrations may produce the principal damaging effect on urban targets following atomic attack. Probability that these mass-fires will occur depends on extent and distribution of ignitions as well as fuel, topographic, and weather conditions. A knowledge of the fire susceptibility of a potential target is important to offensive and defensive military operations and also to civil defense.

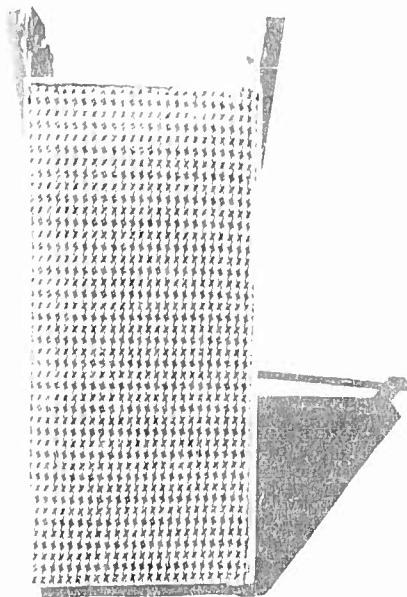
Fig. 2.2 Automobile Seat Display with Fiber Covering over Cotton Upholstery and Foam Rubber Stuffing

portion of the seat material is exposed. It is possible that ignition of cotton body cloth resulted in destruction of the automobile in the three-car grouping which burned at 12.2 cal/sq cm.

The area of car seats exposed to the fireball is small, and the part of this area which is apt to be perpendicular to incident energy is even smaller. Consequently, unless transient kindling fuels, such as newspapers, are present inside or seat coverings are worn to a point where seat stuffing is exposed, automobile seat coverings rarely present a serious ignition problem.

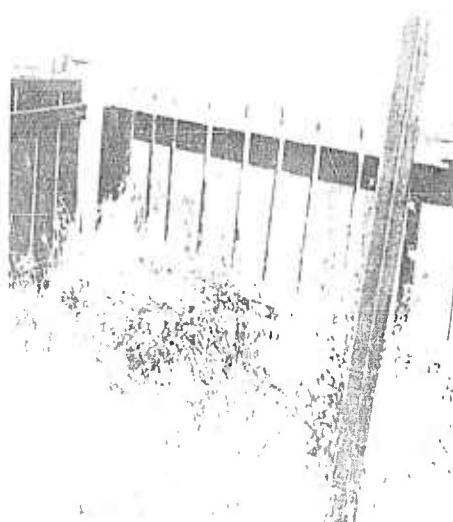
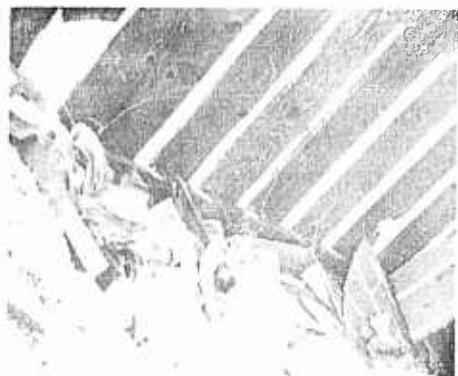
Transient kindling fuels were placed near fence sections (Table 3.5) in a manner simulating the average of worst ignition hazard conditions normally found in cities (see Figs. 2.3, 2.4 and 2.5). These materials had to be held in place by chicken wire during high winds prior to D-day. The new fence and one weathered fence in which rotted wood itself served as a kindling fuel had no transient kindling materials near them.

Fig. 2.3 Comparison of Grass Accumulations

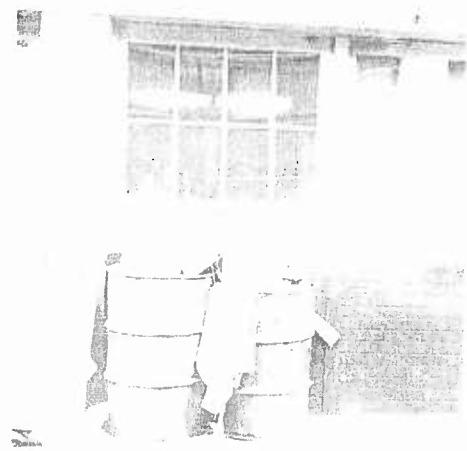
Fig. 2.4 Comparison of Newspaper Accumulations

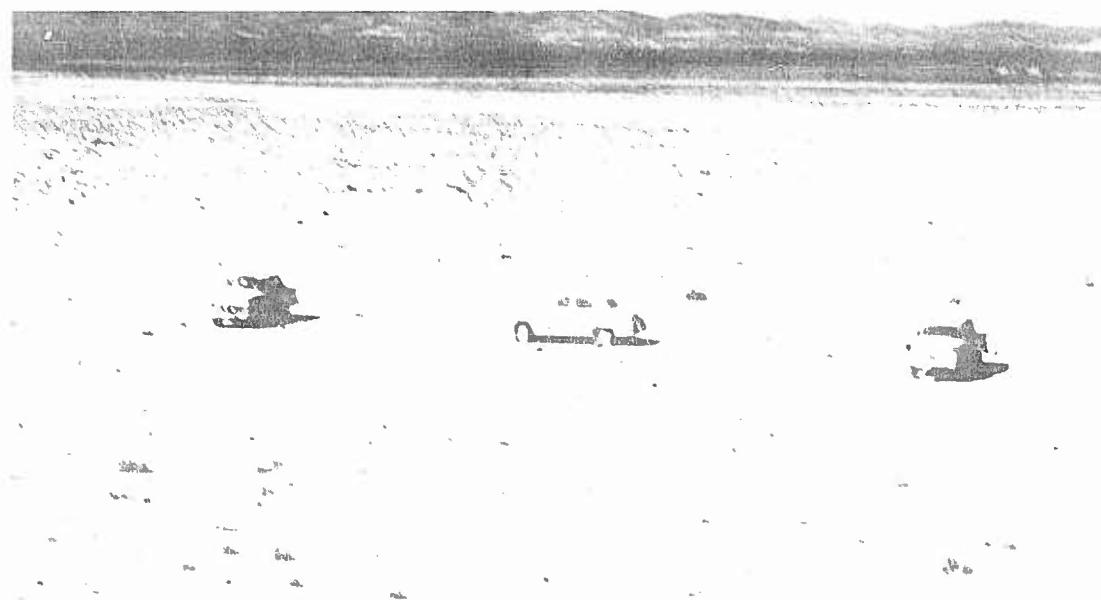
Although no fire was visible from the helicopter at H + 22 min in any of the three car groupings, one was ignited at 12.2 cal/sq cm and burned completely. This car (Fig. 3.2), with the rear window missing and facing away from ground zero, had gray wool upholstery.

Fig. 3.2 Three-car Group at H + 22 min. Car at Extreme Right
Was Burning Vigorously at H + 1-1/2 hrs--Shot 9

Lack of fire detection by cursory observation is not limited to automobiles, but is common to upholstered furniture and rotted wood. Helicopter observers did not detect smoke or fire in the car shown in Fig. 3.2, which later burned; at H + 35-1/2 min no smoke was visible in the left-hand blockhouse of Project 8.11a, yet the recovery party had to extinguish fire in it about an hour later; motion pictures of burning rotted logs at TUMBLER-SNAPPER show no smoke or fire for 10 to 15 min at a time. Similarly, fire was visible from the helicopter in only two cars while pictures indicated that smoke was coming from four vehicles. Nevertheless all cars in the compact group burned, and there is no evidence to suggest spread from one vehicle to another.

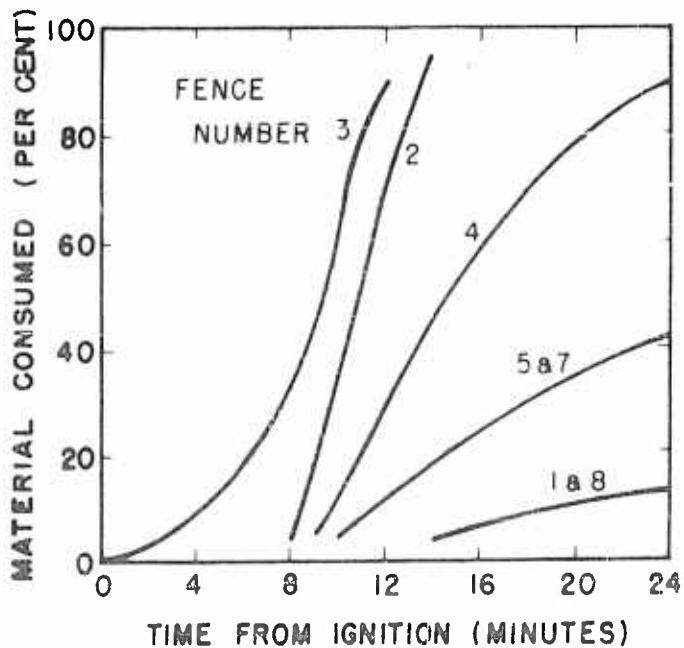
Fig. 3.4 Comparison of Amounts of Material Consumed with Time for Fences Exposed--Shot 9

Examination of time-sequence movies indicates that the main effect of kindling fuels on weathered fences was to increase the rate of fire build-up. Fire build-up, as measured by the relative amount of material of fence consumed with time (Fig. 3.4) was affected more by the kind, arrangement, and amount of kindling fuel present than by the orientation of the fence with respect to ground zero. For instance, in 12 min, fence 2 with newspaper was completely consumed whereas fence 1 barely started burning.

The fact that fences 1 and 8 burned at the same rate indicates that the grass fire contributed little to fire build-up, probably because the grass fire appeared to be extinguished by the blast wave^{4/}. The fiberboard carton and newspaper in the trash can also contributed little. In fact the fiberboard carton in front of fence 5 was visible in Fig. 3.3 at H + 21 min. It is evident that effective and relatively safe kindling material storage or disposal would utilize metal trash cans, covered fiberboard cartons and newspapers tied in compact bundles.

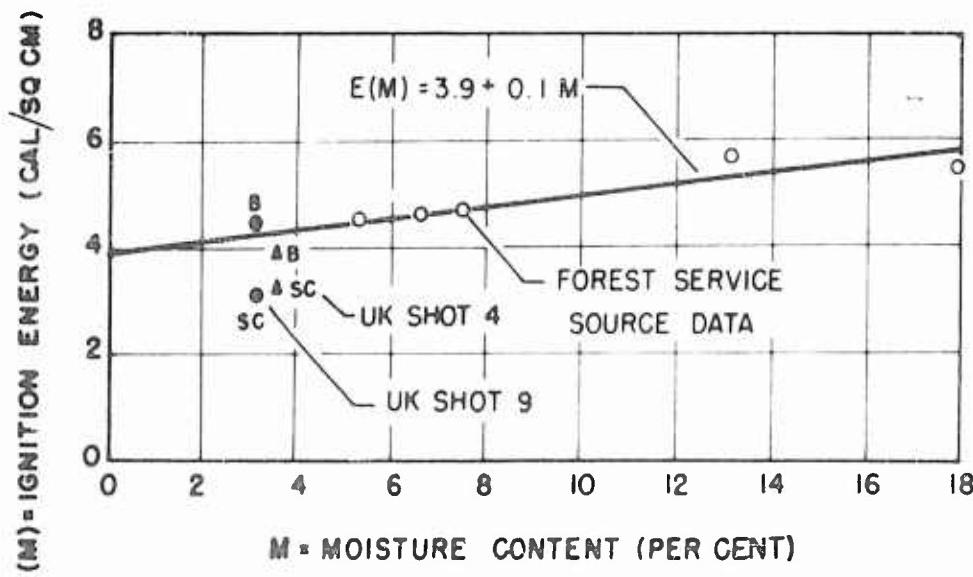
Field ignition energies for newspaper and pine needles are compared with laboratory values in Figs. 4.1 and 4.2. Data for these fuels were selected for comparison, because complete laboratory tests had measured variation of ignition energy with moisture content. These laboratory exposures were made by the Forest Products Laboratory using the Forest Service 12 in. x 12 in. source at 2600°K. Data on pine needles represent samples taken from both newly fallen and one to two year old needles. Field ignition energies can only be specified between the lowest ignition value (B) and the highest non-ignition value (C) due to finite spacing of fuels during exposure. Interpolation

Fig. 4.1 Critical Ignition Energy for Sustained Burning--Crumpled Newspaper, Approximately 0.004 in. Thick, Used but Unweathered. Exposure normal to incident radiation. B--burned; SC--slight char.

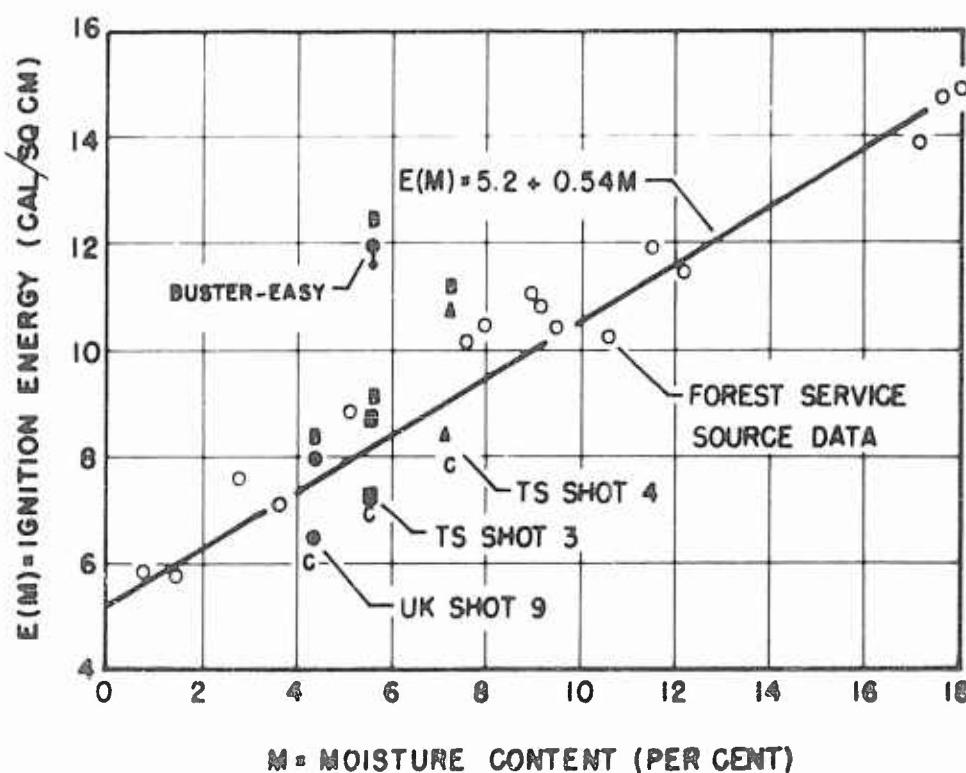
Field exposures of pine needles made on various shots allow comparison of data obtained under various fuel moisture conditions. Fuel moisture values shown in Fig. 4.2 for TUMBLER-SNAPPER are lower than values quoted in WT-506^{2/} which were determined from sampling fuel beds located approximately 8 miles from the exposed beds. Under conditions of falling humidity, such as existed at shot times, fuel moisture of the bed lags behind that of the surface. Since ignition takes place on those surfaces most exposed and since moisture contents of these surfaces will follow closely the change of relative humidity, equilibrium moisture content values were used in reducing all data. Using these equilibrium moisture contents agreement between critical ignition energy as determined in the laboratory and in the field is excellent.

Fig. 4.2 Critical Ignition Energy for Sustained Burning--Ponderosa Pine Needles. Exposure normal to incident radiation. B--burned; C--charred.
